# Plot 6 Development at Keppel Island

## Environmental Study Report

Prepared for                      Keppel Land Pte Ltd  
Represented by                Mr Choo Choong Yow

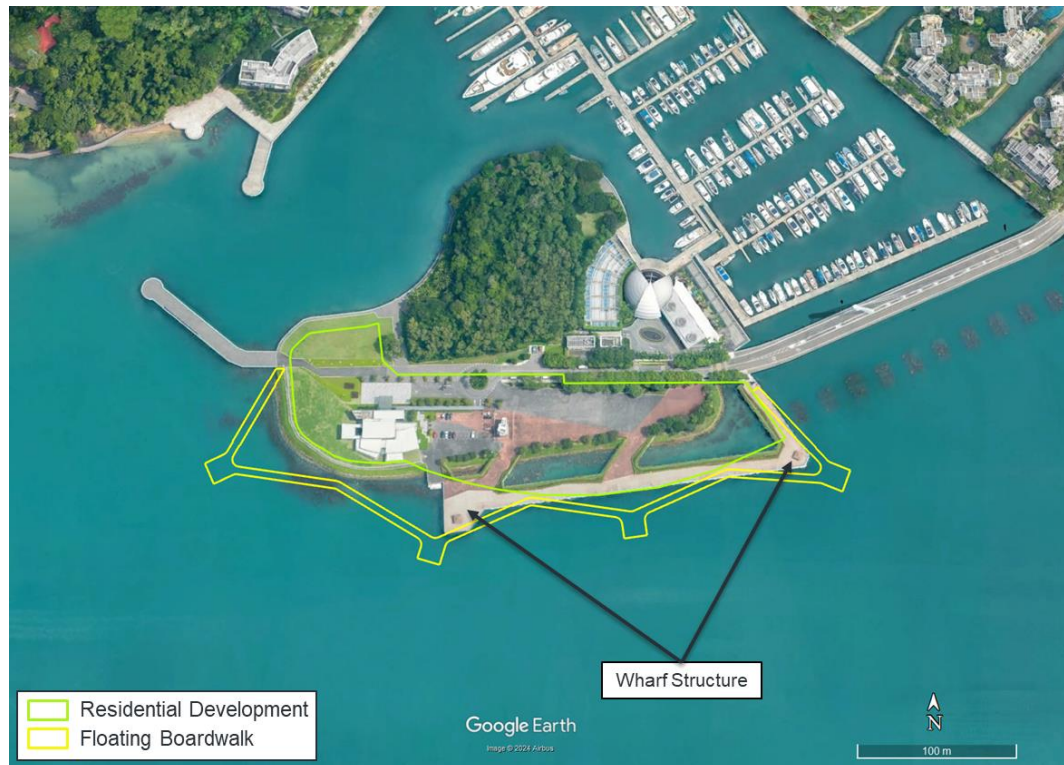
Figure 1.1 Map of the spatial extents of the residential development and floating boardwalk at Keppel Island (Source: Google Earth image @ 2024 Maxar Technologies)

DHI Water & Environment (S) Pte. Ltd. (“DHI”) has been commissioned by Keppel Bay Pte. Ltd. (henceforth termed the “Client”) to conduct an Environmental Study (ES) (henceforth referred to as “Study”) for the construction of a residential development and its associated developments on Keppel Island (henceforth termed the “Project”). These include demolition of the Keppel Marina Multi-purpose Berth MKPM on the southern part of Keppel Island (henceforth termed as the “Wharf”), and construction of a pile deck and floating boardwalk (Figure 1.1).

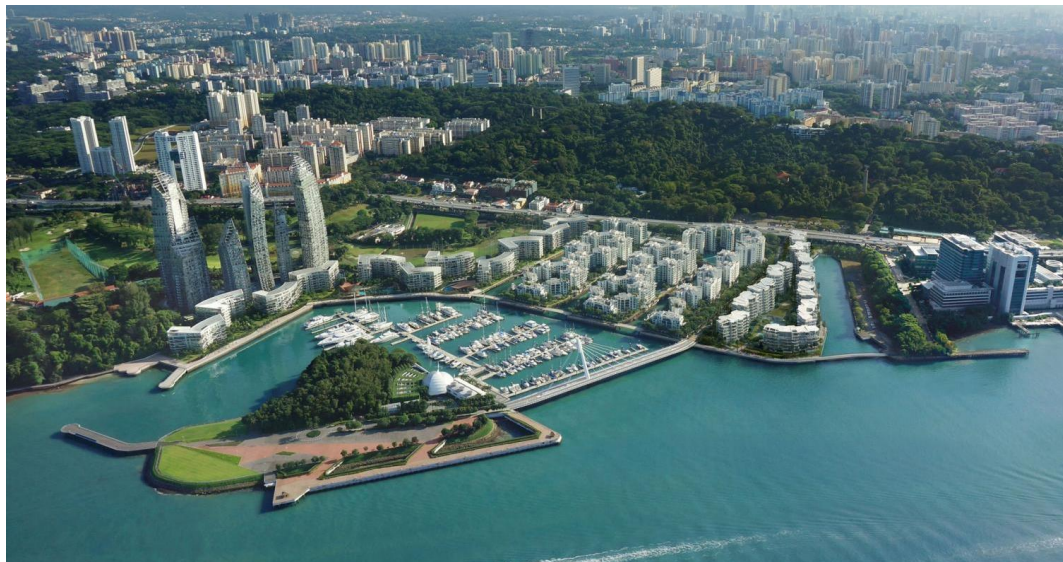
Figure 2.1 Overview of the profile of Keppel Island (source: Client)

The proposed Project site is located on Keppel Island (Figure 2.1), west of the southern tip of mainland Singapore. The island is connected by a bridge to the mainland (henceforth termed “Keppel Bridge” or “Keppel Island Vista”), which is linked to the end of a coastal boardwalk from Labrador Nature Reserve. This pathway crosses large private residential areas such as Reflections at Keppel Bay and Caribbean at Keppel Bay. Keppel Island is approximately 5 ha in size. Its southern half comprises manicured fields and small grass pastures, while the northern half comprises approximately 1.5 ha of coastal forest. The proposed Project site is within the southern half of Keppel Island, also designated as “Plot 6” (~2.2 ha in size), while the northern coastal forest is termed the “Hillock Area” herein.

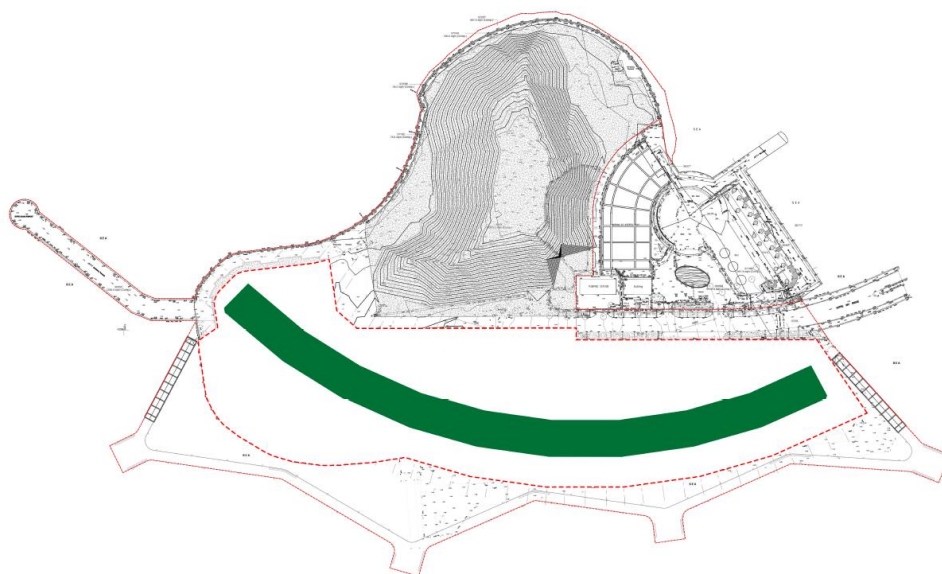
Figure 2.3 Plan view drawing of proposed residential development, including the existing Hillock Area in the north and floating boardwalk to the south (source: Client)

The proposed Project is a low-rise residential development at Keppel Island. With the retention of the Hillock Area in the north, and the construction of a new 5 m wide floating boardwalk in the south, the Project is surrounded by greenery or marine waters.

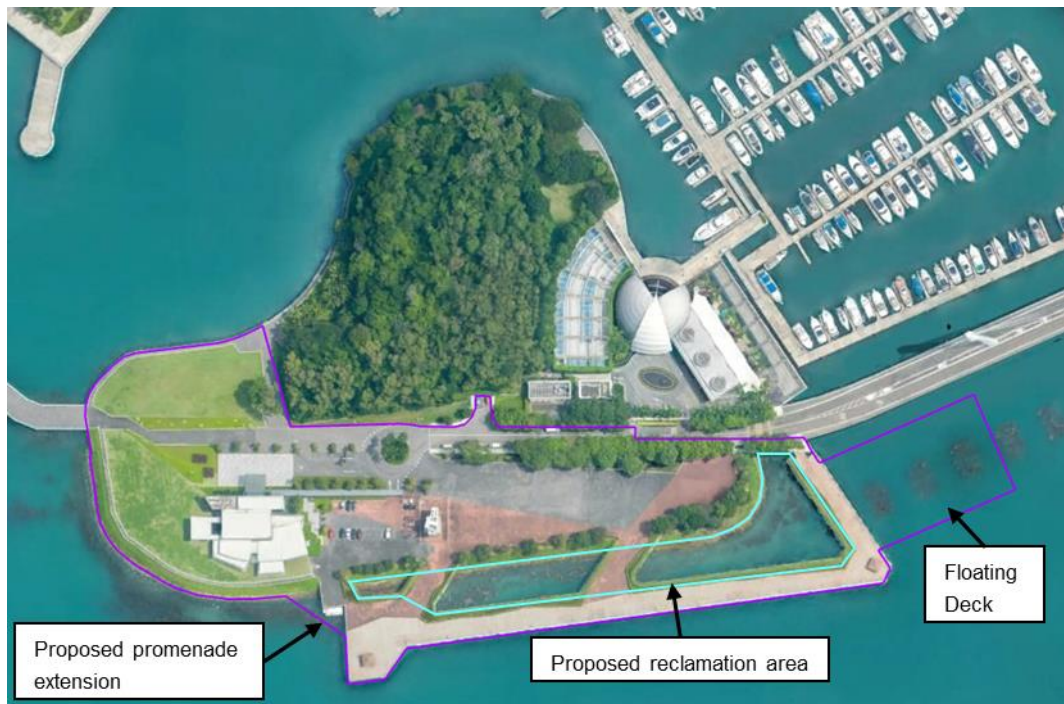
Figure 2.4 Map of the construction design during the submission for the environmental consultation for Plot 6

The environmental consultation was approved on 5<sup>th</sup> October 2023. The proposed design proposed reclamation within the three (3) existing lagoons south of Keppel Island, the extension of the Wharf on the western end, and the addition of a floating deck to the east (Figure 2.4). In the response, it was noted that works are in close proximity to several sensitive receptors, which would result in airborne and underwater noise emissions, air pollution and sediment plumes. In the long term, loss of corals and intertidal areas is also expected. DHI was requested to consult the Technical Agencies (NParks, MPA, and NEA) to scope the Environmental Study and was expected to have an engagement with the nature group(s) before the Environmental Study report can be accepted by the developer. Finally, the report is expected to be disclosed for public feedback. Results collected for this Study are also required to adhere to the authorities' standardisation guides for data storage.

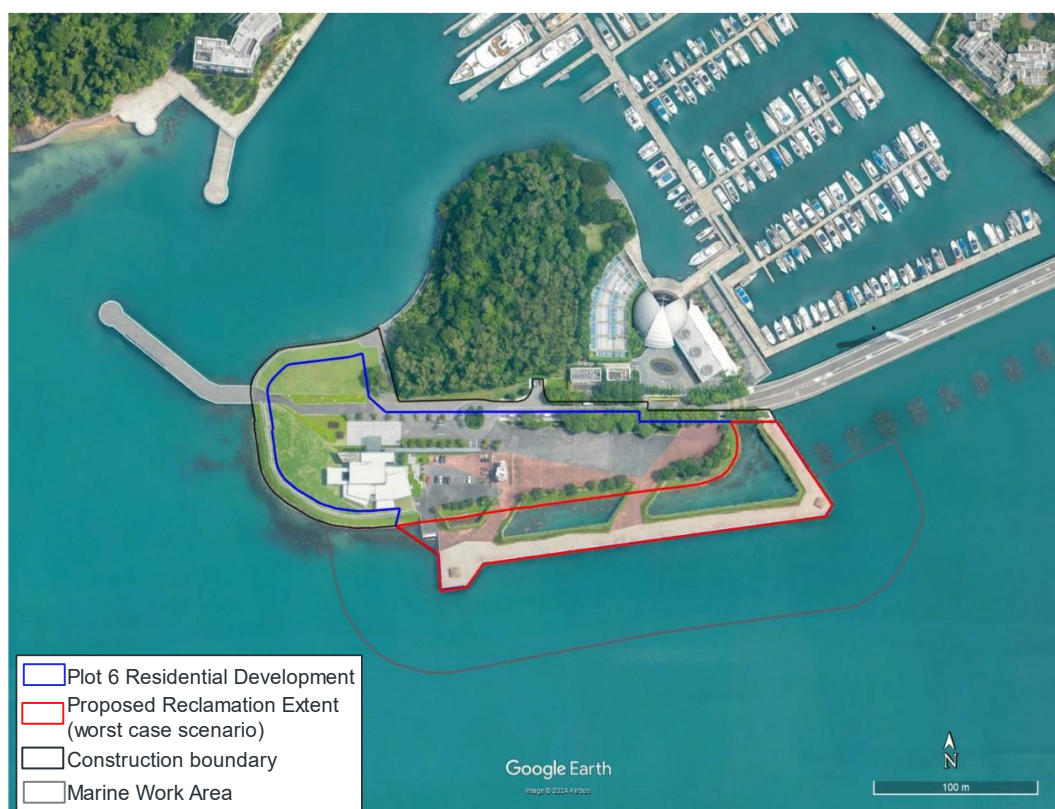
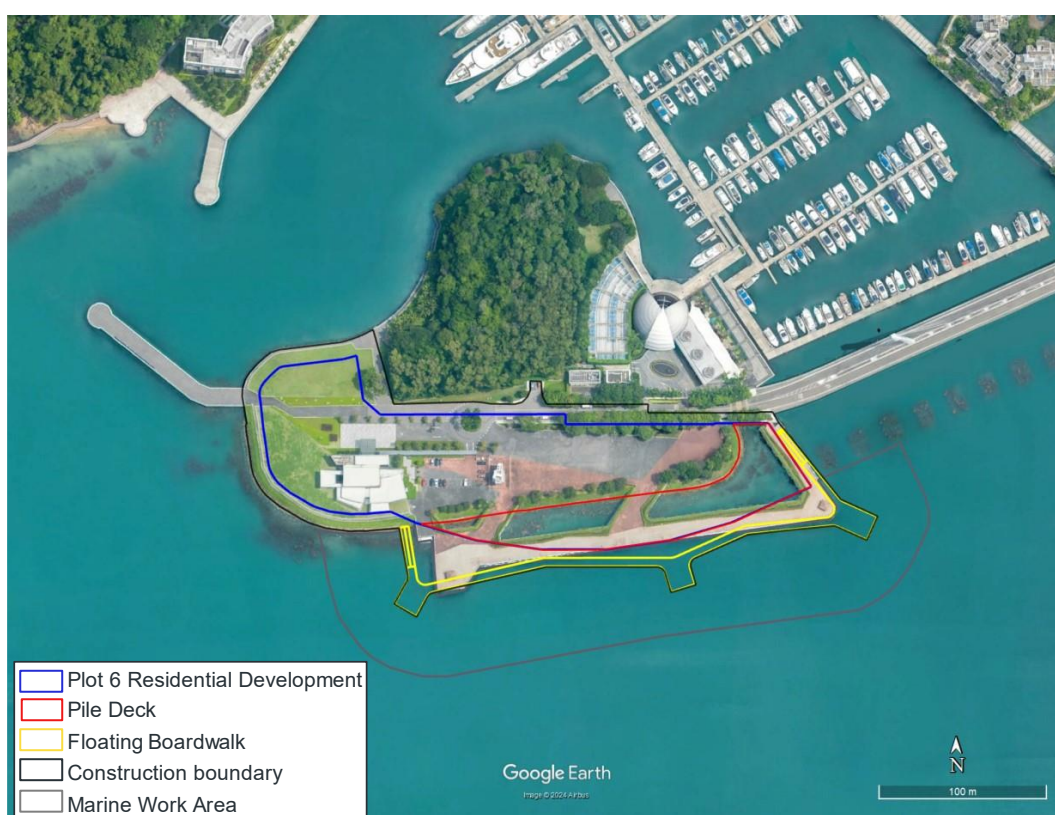
**Figure 2.5** Maps showing the designs proposed for Plot 6. Two designs share the same footprint with one design carrying out reclamation in the Proposed Reclamation Extent (top), and another carrying out pile decking in the same area (bottom). The third design is a combination of piling and the construction of a floating boardwalk.

The designs are as follows: 1) reclamation; 2) construction of a pile deck and; 3) floating boardwalk (Figure 2.5). Among the scenarios, reclamation was considered as the “worst-case” due to greater loss of ecological habitat and more pronounced change in hydrodynamics. In the event that one of the other alternative methods (pile deck or floating boardwalk) was chosen instead, the Environmental Study will only assess impacts relevant to the chosen method. One of the major differences in the impact assessment scope is the inclusion of wave modelling only in the worst case (i.e., reclamation) construction method. This is because the creation of new land would require reinforcement using a new vertical sea wall, which could result in the reflection of waves, and potential shipwake impacts and changes to the wave environment. However, because the waves in this area are generally calm due to the sheltered location, wave modelling and assessment was scoped out for the non-worst-case scenarios (i.e., pile deck and floating boardwalk designs).

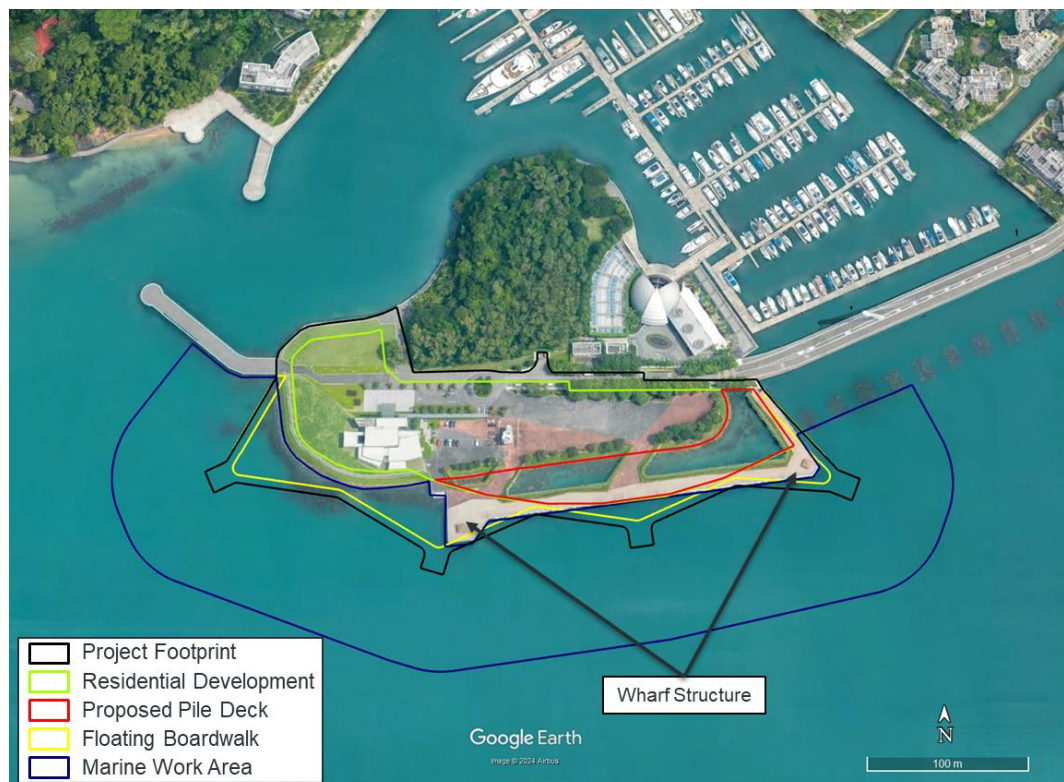
Figure 2.6 Chosen construction design for Plot 6's residential development and floating boardwalk

After discussions with authorities, the floating boardwalk method was chosen as the construction method and it comprises of a pile deck that provides a foundation to support the residential building, and a 5 m wide floating boardwalk. The floating boardwalk's layout connects the existing breakwater jetty on the west of Keppel Island and the edge of the Keppel Bay Bridge to the East of Keppel Island (Figure 2.6). The floating boardwalk was designed to be accessible in compliance with the Building and Construction Authority's Code on Accessibility in the Built Environment (2019). Therefore, it provides a longer waterfront experience for the public.

The footprint of Plot 6's residential development, construction boundary and extent of the proposed pile deck were provided by the Client. The marine work area was estimated to be 60 m based on the use of towboats which would be required to adjust/secure the floating boardwalk onto the piles.

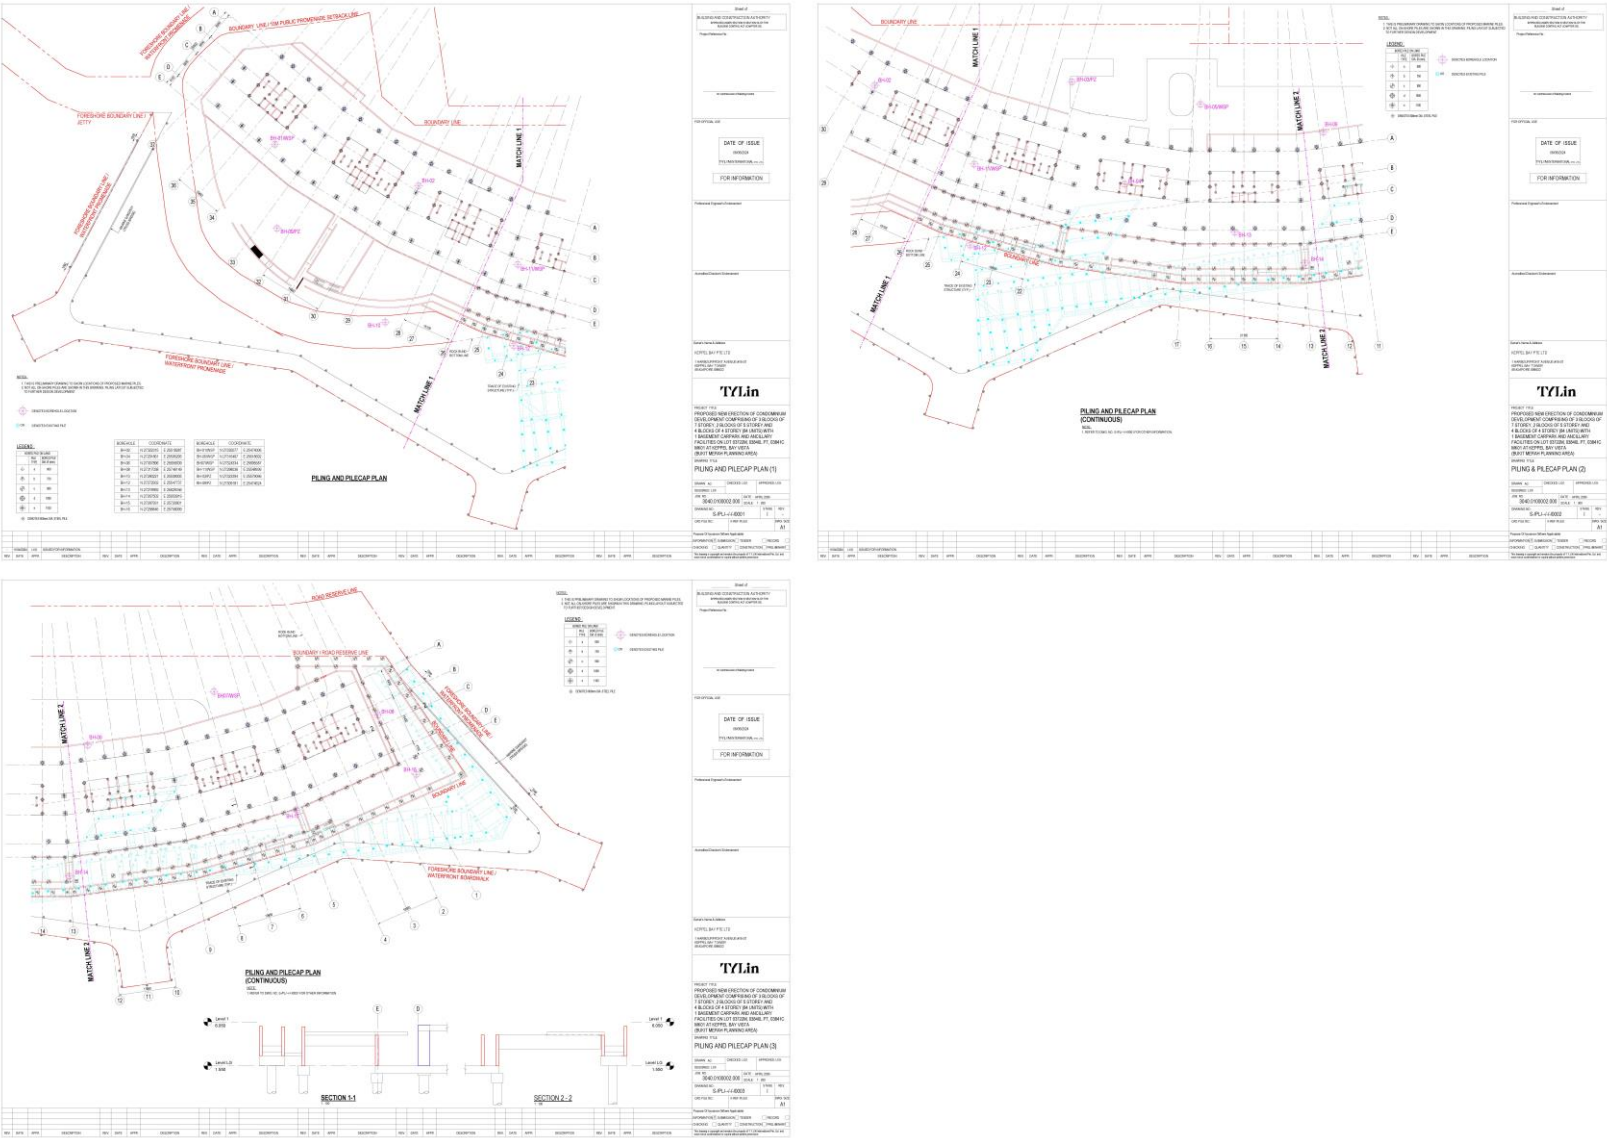
Figure 5.10 Overview of piling plan with indicative pile sizes for the Project (source: Client)

Based on information from the Client, the construction duration for the installation of the marine pile is approximately 32 weeks. The Project involves the construction of two key structures, the pile deck for the residential building and the floating boardwalk, with a total of 354 piles to be installed in the water (Figure 5.10 and Figure 5.11). 222 piles will be installed for the pile deck and 132 piles for the floating boardwalk. Five (5) different pile diameters will be used: 1.1 m, 1.0 m, 0.9 m, 0.75 m, and 0.6 m. The construction of the marine piles comprises piling, cage insertion, and infilling. However, only the piling is considered in the model, as the other activities were determined to contribute relatively minimal amounts of sediment plume. According to the construction schedule, two (2) piles will be installed per day, with the assumption that construction hours are eight (8) hours per day and six (6) days per week. The model also conservatively assumes that two piles will be installed concurrently, using two different barges, within a 30-minute time duration. Finally, the piles for the pile deck and the floating boardwalk were simulated separately. Hence, Scenario 1 and Scenario 2 were simulated for piles in the pile deck, and Scenario 3 and Scenario 4 were simulated for piles for the floating boardwalk.

Due to the large number of piles, DHI designed piling scenarios which simulated the worst-case construction situation. The construction sequence of the piling works was assumed to commence from the southeast corner of the island, at the inner most layer of piles. Piles will be placed sequentially, progressively moving outwards to the next layer in a zig-zag manner (i.e., first towards the west, then to the east and back to the west). The piles east of the pile deck were selected to simulate the worst-case scenario for the receptors east of the Project (Figure 5.12). The piles at the west side of the floating boardwalk were selected to simulate the worst-case scenario for the receptors on the west side of the Project (Figure 5.13). The detailed sizes of the piles and the number of piles simulated per day in each scenario are presented in Table 5.4 and Table 5.5. Further details on the spill rate calculation and assumption are described in **Appendix B**.

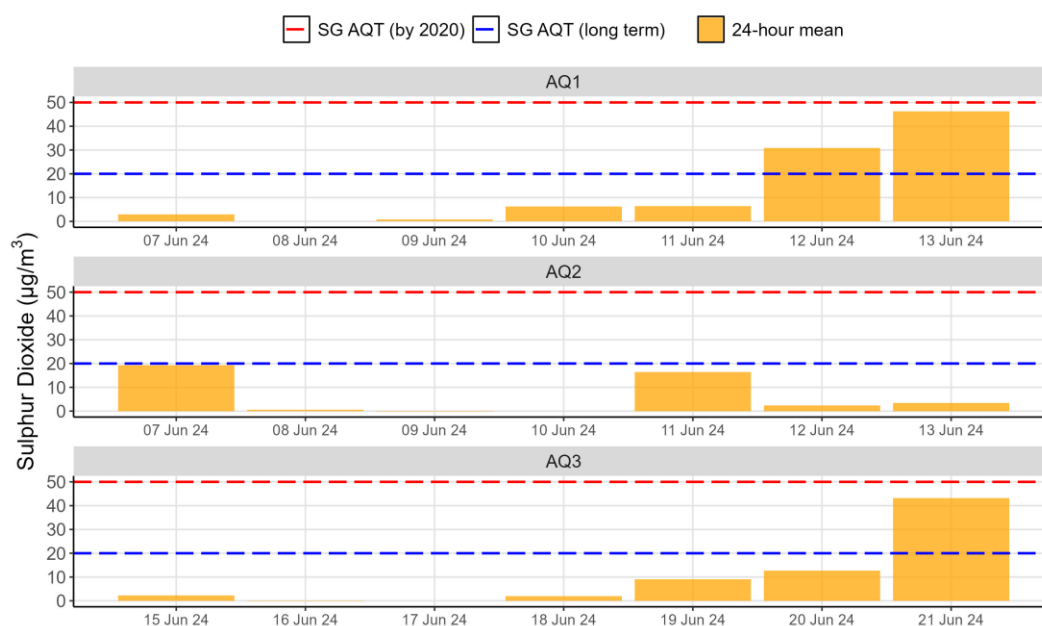
Figure 5.40 Measured 24-hour mean SO<sub>2</sub> concentrations at AQ01, AQ02, and AQ03 and the benchmarked SG AQTs

The measured 24-hour mean SO<sub>2</sub> concentrations are plotted in Figure 5.40. The 24-hour mean SO<sub>2</sub> concentrations across all three (3) stations were below the SG AQT (by 2020) but were above the long-term SG AQT on 12 June and 13 June 2024 at AQ01 and on 21 June 2024 at AQ03. It is noted that SO<sub>2</sub> concentrations in the area were high, with occasional high spikes of up to 260.74 µg/m<sup>3</sup> recorded at AQ03 during the monitoring period. The localised high SO<sub>2</sub> is likely attributed to emissions from vessel movements around Keppel Island.

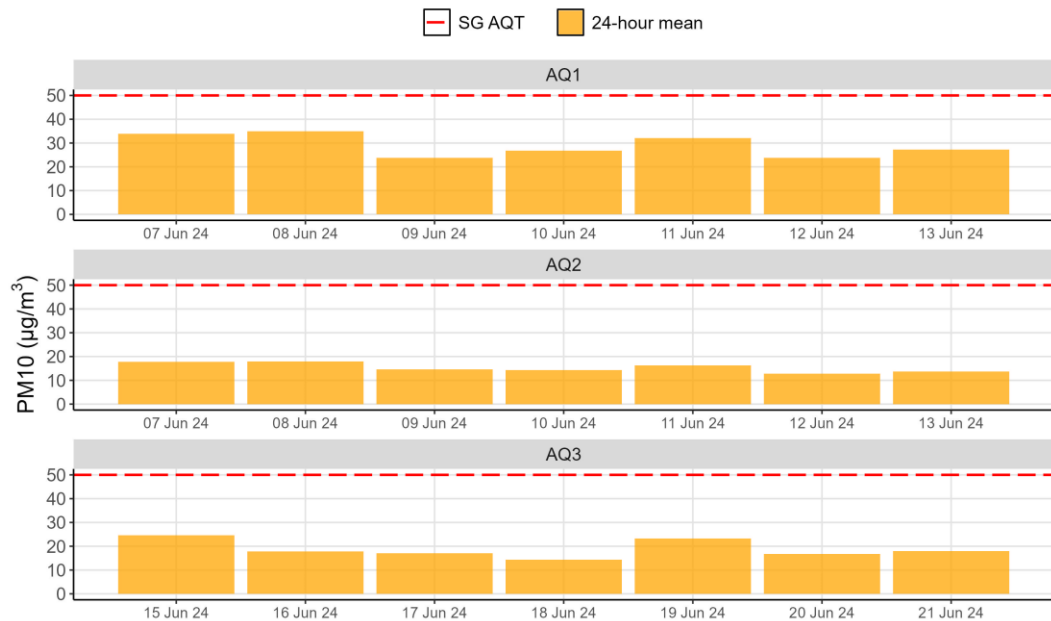
Figure 5.41 Measured 24-hour mean PM<sub>10</sub> concentrations at AQ01, AQ02, and AQ03 and the benchmarked SG AQT

The measured 24-hour mean PM<sub>10</sub> and PM<sub>2.5</sub> concentrations are plotted in Figure 5.41 and Figure 5.42, respectively. The SG AQTs were not exceeded during the monitoring period except for the long-term SG AQT for PM<sub>2.5</sub> on 07 June and 08 June 2024 at AQ01. The generally high PM<sub>10</sub> and PM<sub>2.5</sub> concentrations could be a potential contribution from sea spray due to the close proximity of the monitoring station to the sea.

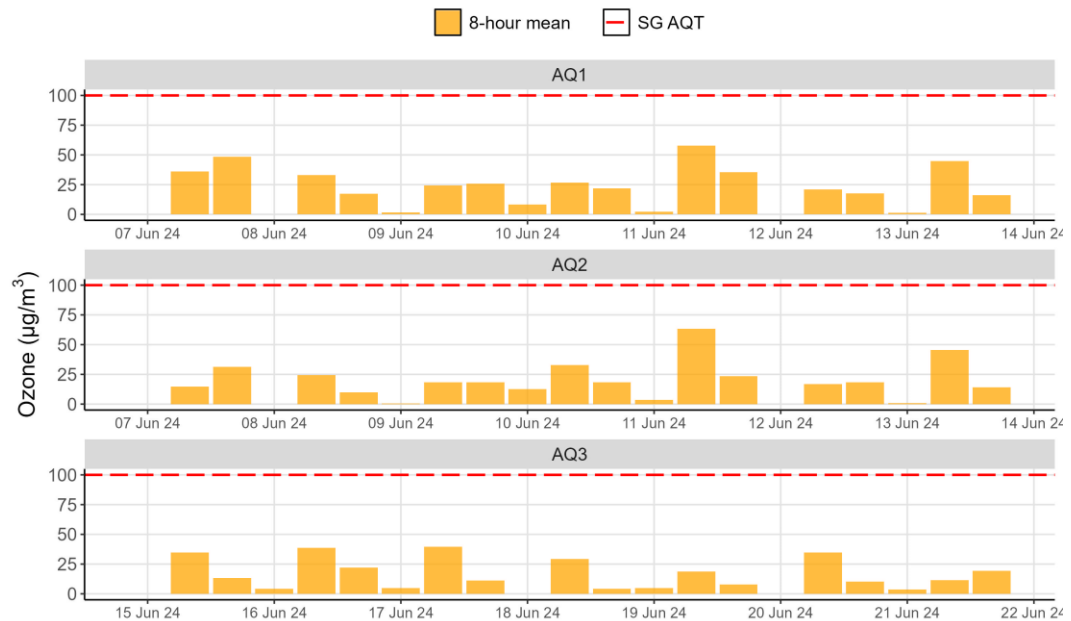
Figure 5.43 Measured 8-hour mean  $O_3$  concentrations at AQ01, AQ02, and AQ03 and the benchmarked SG AQT

The measured 8-hour mean O<sub>3</sub> concentrations are plotted in Figure 5.43. The 8-hour mean O<sub>3</sub> concentrations recorded at AQ01, AQ02, and AQ03 during the monitoring period were below the benchmarked SG AQT. Please note that ozone in ambient air is not from a direct emission, but a secondary pollutant formed from a chemical reaction between nitrogen oxides and volatile organic compounds driven by sunlight.

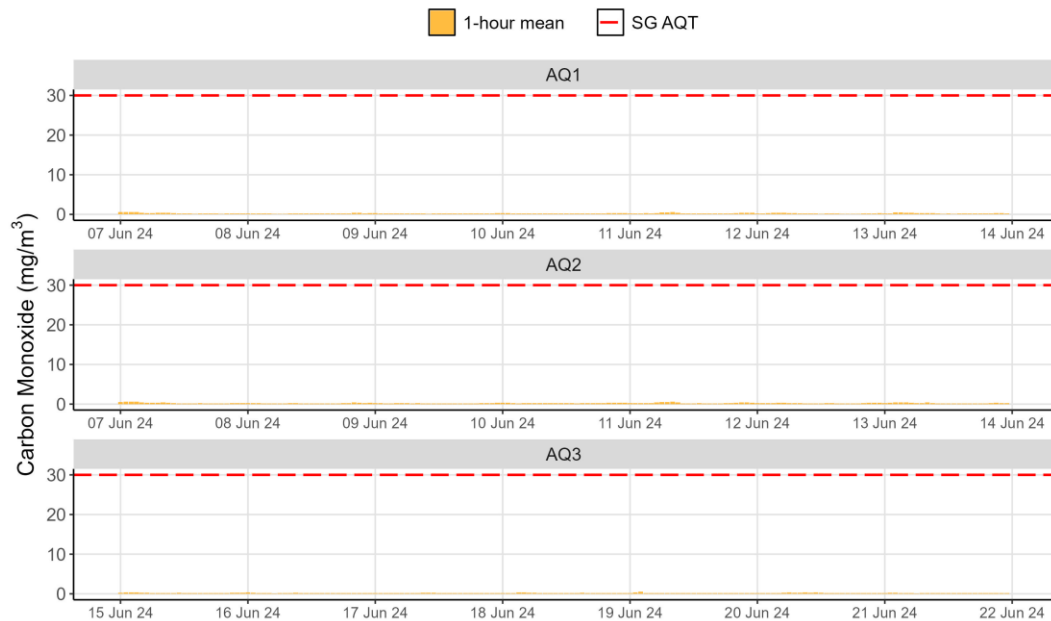
Figure 5.45 Measured 1-hour mean CO concentrations at AQ01, AQ02, and AQ03 and the benchmarked SG AQT

The measured hourly and 8-hour mean CO concentrations are plotted in Figure 5.45 and Figure 5.46. The 1-hour and 8-hour mean CO concentrations recorded at AQ1, AQ2, and AQ03 during the monitoring period were below the benchmarked SG AQTs. The main CO contributor is likely from road and/or vessel traffic, with no other known CO emission sources in the area.

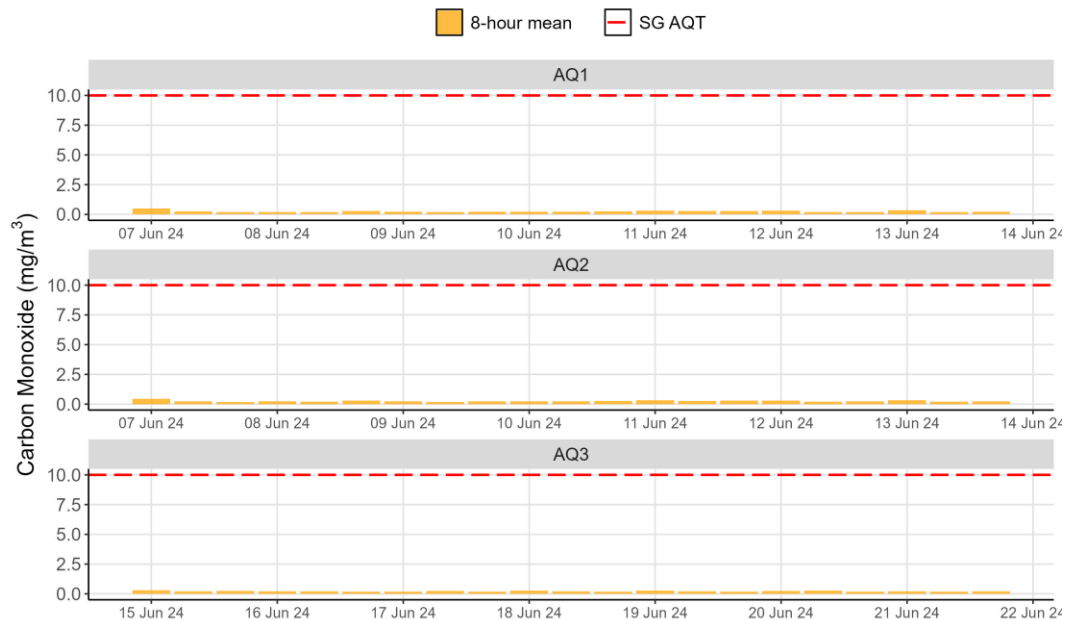
Figure 5.46 Measured 8-hour mean CO concentrations at AQ01, AQ02, and AQ03 and the benchmarked SG AQT

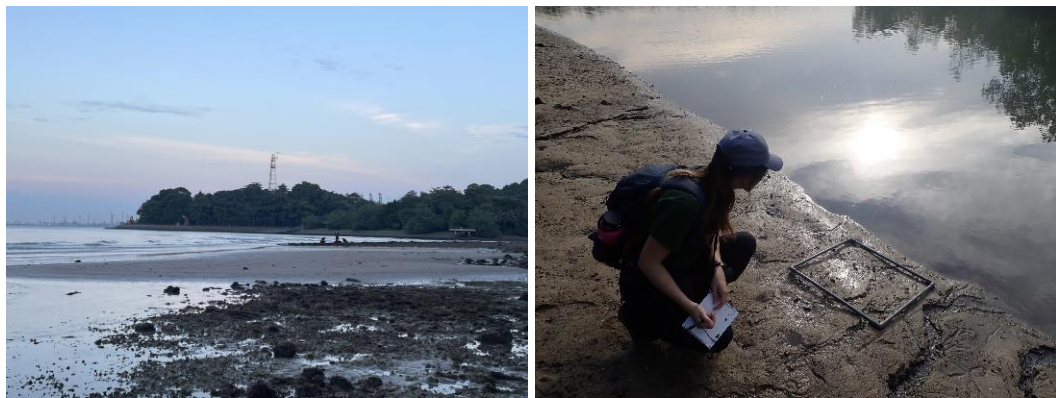
Figure 5.62 Images showing an overview of the intertidal area at Berlayer Creek (left) and a surveyor quantifying benthic coverage on the intertidal area (right)

The Visual Quadrat Point (VQP) method (Figure 5.61) was used due to the narrow nature of the intertidal area near Keppel Island and the patchy seagrass at the mouth of Berlayer Creek. Surveys were conducted during periods of spring low tide. Six (6) replicate 0.25 m<sup>2</sup> (0.5 m by 0.5 m) quadrats were placed randomly around each predetermined point, which were distributed across the site (Figure 5.63) to ensure adequate representation of the Study Area.

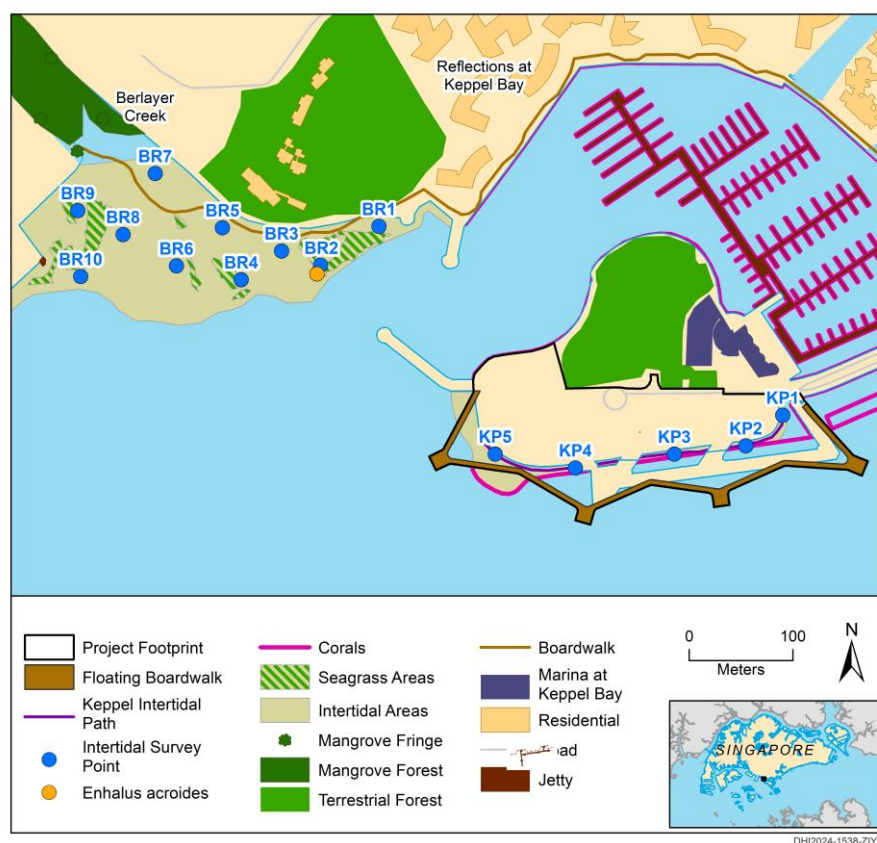
Figure 5.63 Location of intertidal survey areas and point stations, ten (10) at Berlayer Creek and four (4) at Keppel Island. Conservation-significant species of seagrass detected during surveys are also marked.

Berlayer Creek intertidal area is located northeast of Keppel Island, separated by a 50 m wide navigation channel leading into the Marina at Keppel Bay. Due to the substantial area that needed to be covered, ten (10) points along the intertidal area were identified for surveying (Figure 5.63; Table 5.36).

The intertidal area of Keppel Island is located on its southern coast, approximately 300 m in length. Five (5) points along this coast was identified for surveying (Figure 5.63; Table 5.37).

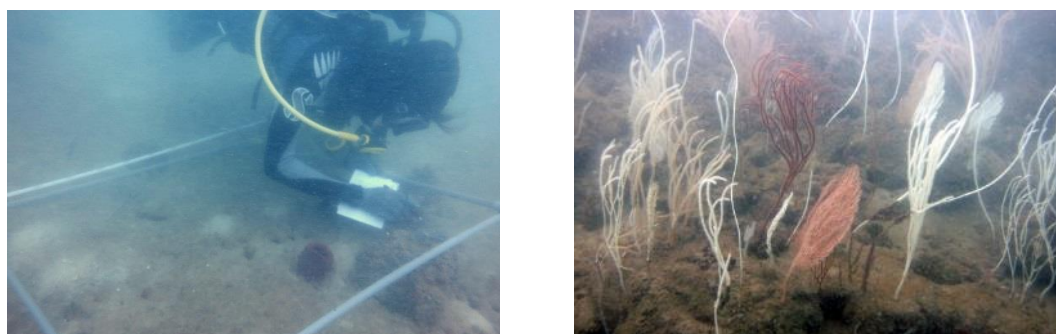
Figure 5.70 Recording and counting target organisms within a quadrat (left); High density of sea fans and sea whips along the lower reef (right)

Along the lower reef, three (3) replicate transects measuring 10 m will be laid in a longitudinal direction to the reef, with a 10 m interval between each successive transect. Quadrats measuring 1 m<sup>2</sup> will be sampled at every other meter on alternate sides of each replicate transect (Figure 5.70). The number of colonies from each target group listed in Table 5.46 will be counted within each quadrat. Six (6) quadrats will be sampled along each replicate transect.

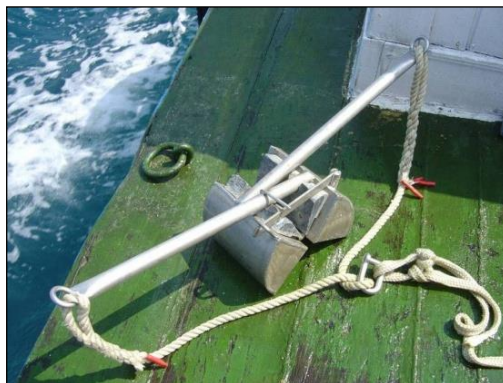
Figure 5.94 Van Veen grab sampler (left); Operation of a Van Veen grab sampler (right)

Grab sampling is one commonly employed method used in the quantitative assessment of the macrobenthic fauna that inhabit the soft-bottom seafloor communities. The seafloor community will be sampled using a Van Veen grab (Figure 5.94), which facilitates the capture of slow moving and sessile epifauna and infauna.

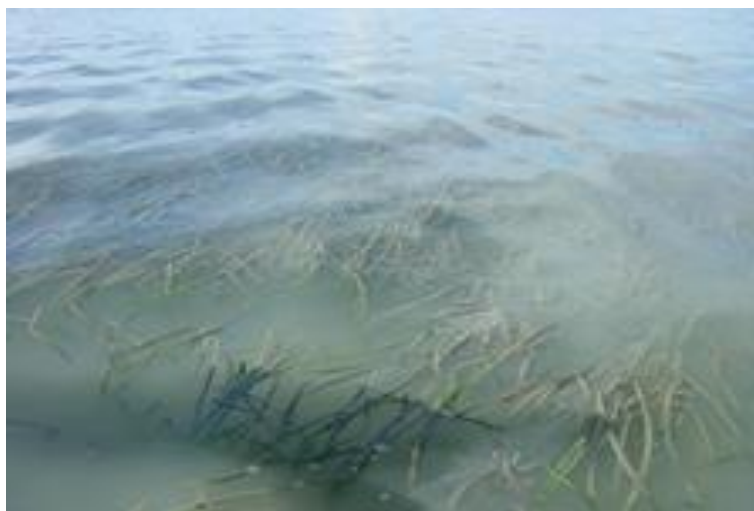
Figure 5.98 Typical seagrass habitat found in Singapore

Working through the equations for a change in limiting habitat water depth of 0.5 m requires an excess concentration between 5 mg/l (deep beds) and 75 mg/l (shallow beds). At low tide, the seagrass in Singapore is often exposed to high levels of suspended sediments, as shown in Figure 5.98. As evident, they can maintain a high level of tolerance. For the deeper meadows, the tolerance is less. However, given the natural background variability in suspended sediment load in the Singapore waters, it is reasonable to assume that the outer limits of the seagrass are well adapted (in terms of water depth) to short-term fluctuations in the background concentration of 5 mg/l to 10 mg/l, such that excess loadings higher than 5 mg/l will be required to induce a noticeable habitat change. These conclusions, coupled with monitoring experience from the region, result in the proposed magnitude of the condition matrix presented in Table 5.60.

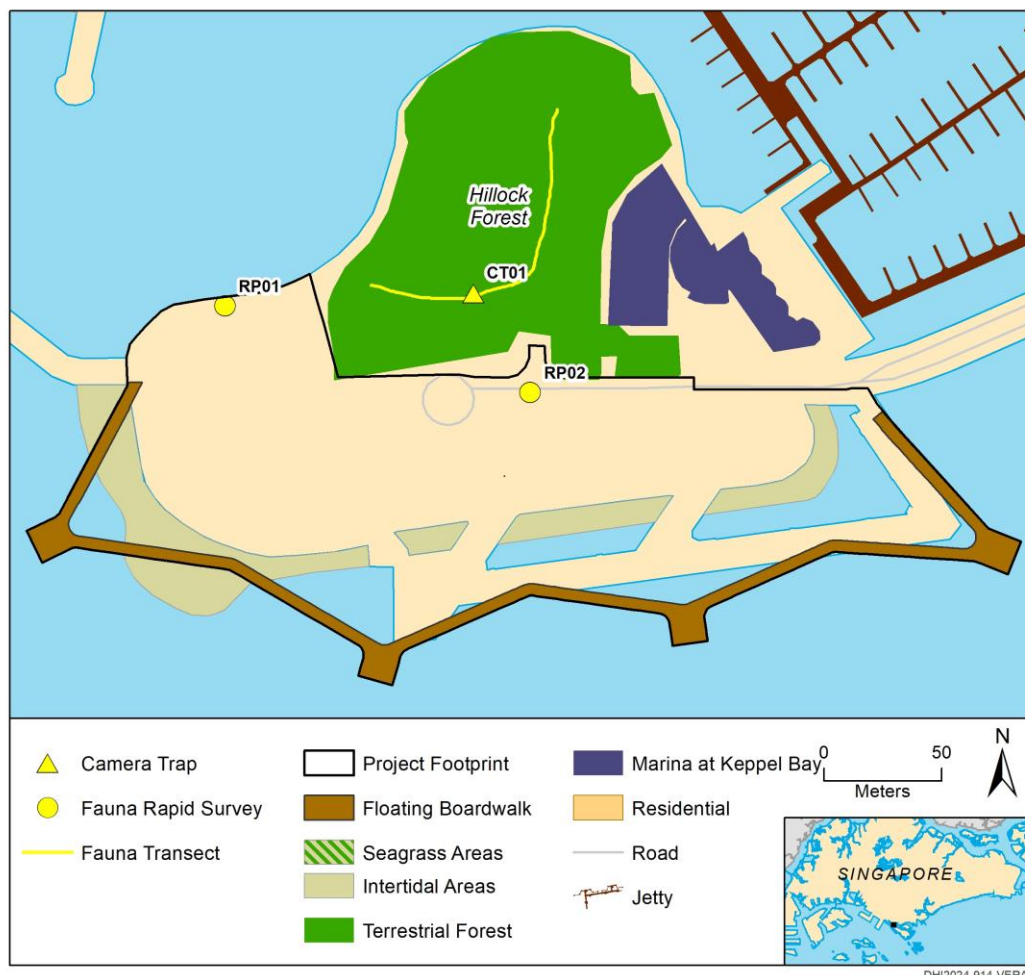
Figure 5.104 Locations of line transect, camera traps and rapid fauna surveys for terrestrial fauna surveys within the Study Area

One (1) line transect of about 143 m in length was established within the Study Area shown above in Figure 5.104. The taxonomic groups of interest for line transect surveys include

In addition, two (2) rapid fauna surveys were carried out at the point locations shown in Figure 5.104 above. The surveys were carried out in open areas targeting all fauna groups (Figure 5.104, Table 5.73) detected around the point at both dawn and dusk. Surveyors stood at the specified points for 30 minutes, recording all fauna encountered via either direct visual sightings or auditory calls. These surveys were intended to detect birds and other fauna utilising the open areas (including birds of prey). RP01 was set to look over Berlayer Creek, while RP02 was focused on birds within the development plot.

Bat surveys consist of visual encounter surveys for frugivorous bats and acoustic sampling for insectivorous (echolocating) bats along the terrestrial fauna line transect, as well as at the two (2) rapid survey points (Figure 5.104). The surveys were conducted between 1930h and 2200h. The Echo Meter Touch 2 Pro Bat Detector (Wildlife Acoustics, Inc.) was used to record, stream, and attenuate ultrasonic calls between 18 and 192 kHz at a sampling frequency of 256 kHz. The bat sonograms were matched to a reference library of bat calls collected from species known to occur within Singapore and the region. Two (2) nocturnal replicates of visual encounter surveys and acoustic sampling were carried out.

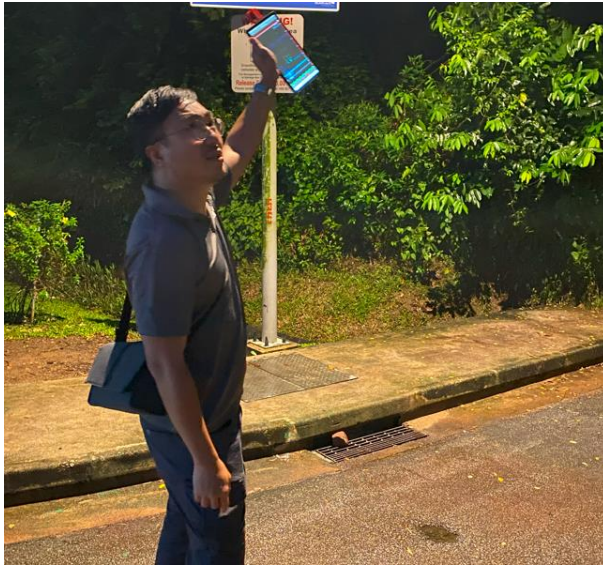
Figure 5.105 A surveyor conducting bat sampling within the Study Area

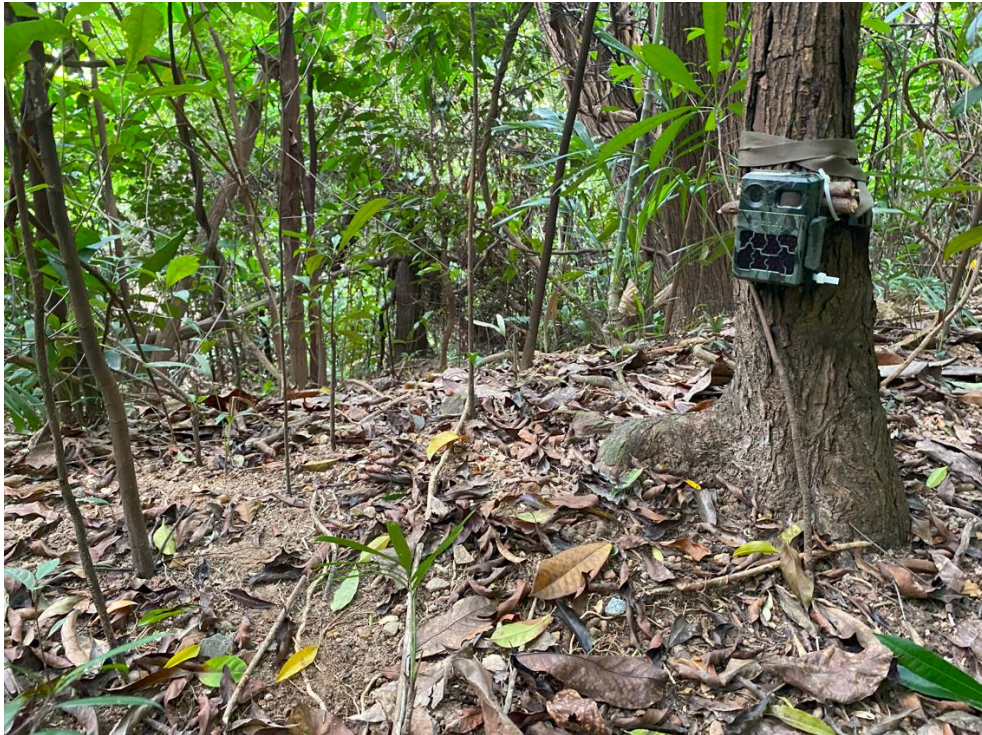
Figure 5.106 Camera trap setup within Hillock Area

Deployment location was selected based on the presence of obvious animal trails or signs or where animal usage was deemed most likely according to habitat characteristics. The camera trap was mounted 30 cm to 50 cm off the ground and secured to a tree (Figure 5.106). The camera was programmed to record a 10-second window of video footage and a burst of three (3) photographs per motion trigger; colour photographs were taken during the day, while infrared photographs were taken at night. The camera traps were maintained every two (2) to four (4) weeks to ensure proper functioning and retrieved after the survey period.

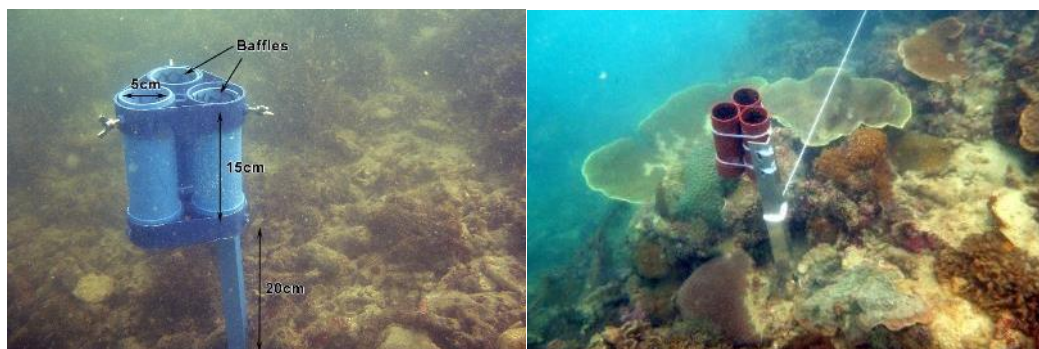
Figure 8.8 Examples of one set of sediment trap deployed along the reef crest

Sediment traps function as measuring devices for sedimentation rate at the monitoring sites and serve to provide feedback and validation for the other monitoring parameters. At each station, the sediment traps would be deployed along the reef crest (0 mCD), where coral cover is typically the highest in Singapore, as three (3) replicates; each consisting of three small cylindrical tubes attached together (Figure 8.8). The replicates would be placed approximately 2 m to 5 m apart to capture local spatial variability. This follows the methods outlined in the Survey Manual for Tropical Marine Resources (English *et al.*, 1997).

The height of the trap opening from the reef substrate would be about 35 cm, held vertical by an angle-bar hammered into a denuded part of the reef (Figure 8.8). Baffles would also be placed in the top of the trap to reduce re-suspension within and exclude any animals that might otherwise enter the trap and affect the results. The sediment traps would also be painted with non-toxic anti-fouling paint to minimise bio-fouling between repeats. These sediment traps would not float, hence, even if any trap gets dislodged from the angle-bar, it will remain on the seabed.

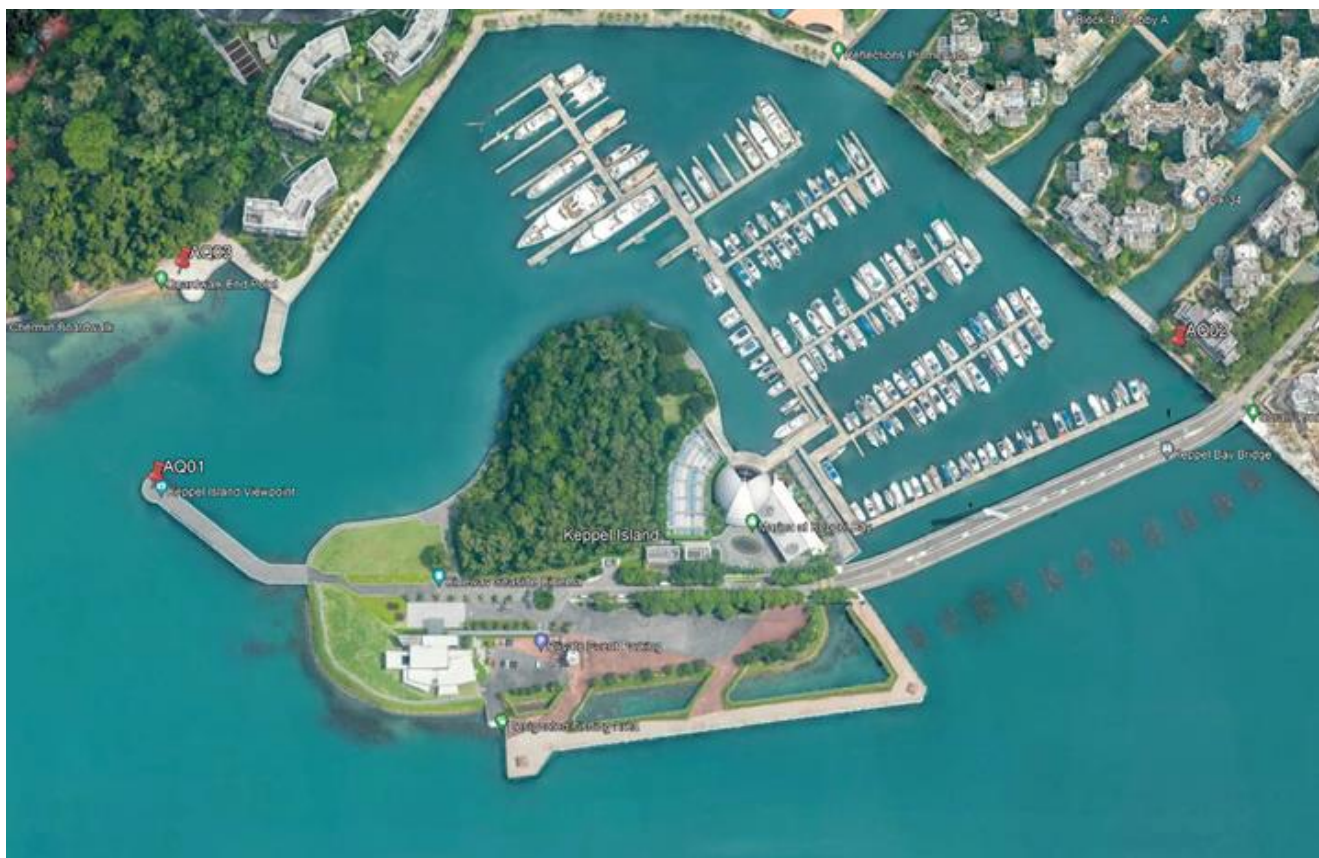
The monitoring location is shown in the Google Map image below. Refer to Appendix A for site photos.

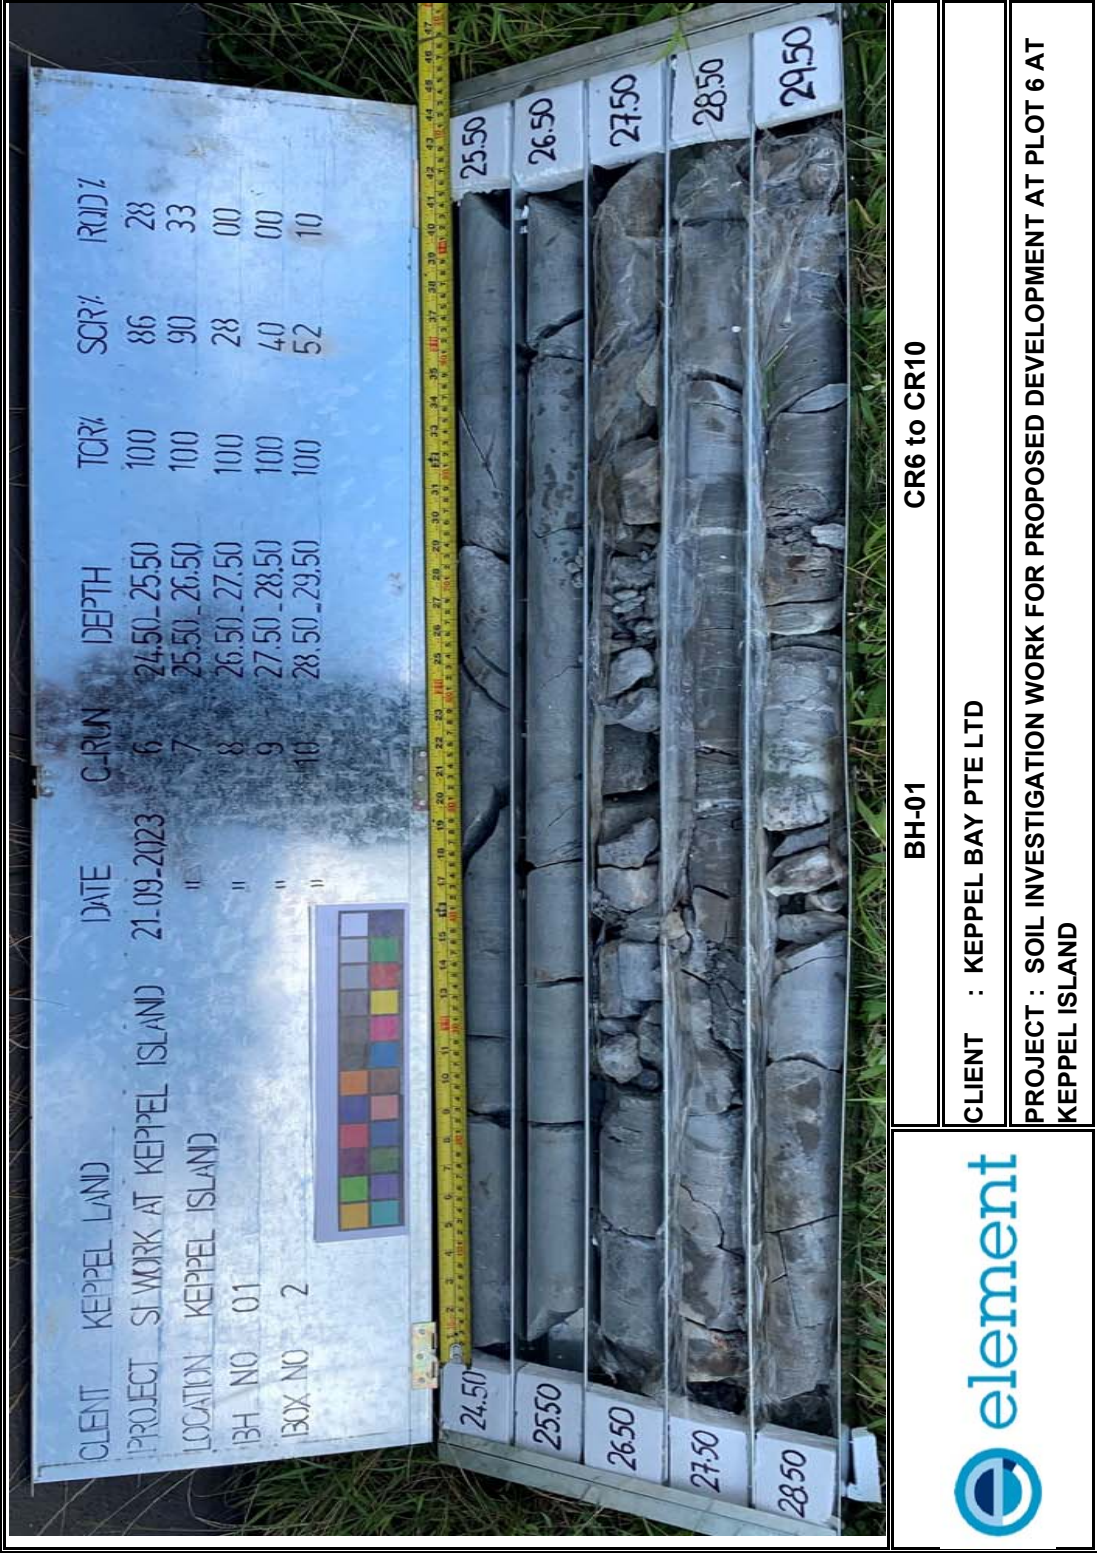
| <div><div>CLIENT - KEPPEL LAND</div><div>PROJECT - SI WORK AT KEPPEL ISLAND</div><div>LOCATION - KEPPEL ISLAND</div><div>BH NO - 01</div><div>BOX NO - 3 OF 3</div></div> <div><div>DATE 21.09.2023</div><div>CIRN 11</div><div>DEPTH 29.50,30.00</div><div>TOR% 50</div><div>SCR% 10</div><div>RQD% 00</div></div> | | | | | | | | | |
