# Plot 6 Development at Keppel Island

## Environmental Study Report

Prepared for                      Keppel Land Pte Ltd  
Represented by                Mr Choo Choong Yow

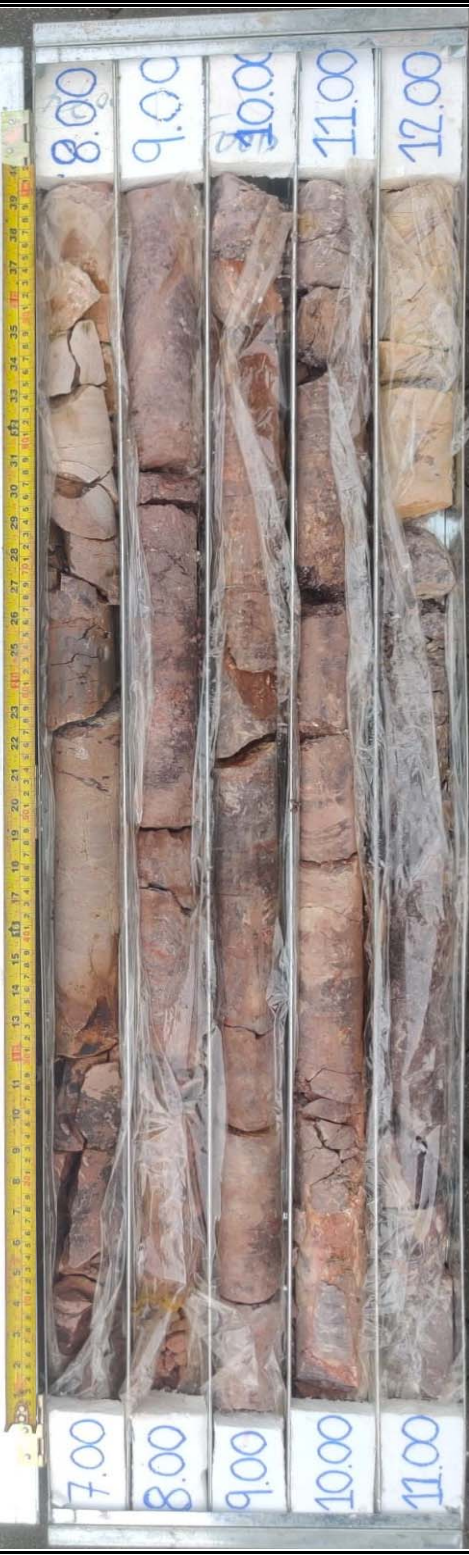
| | | | | BH-05 | | | |

| | | | | CR6 to CR10 | | | |

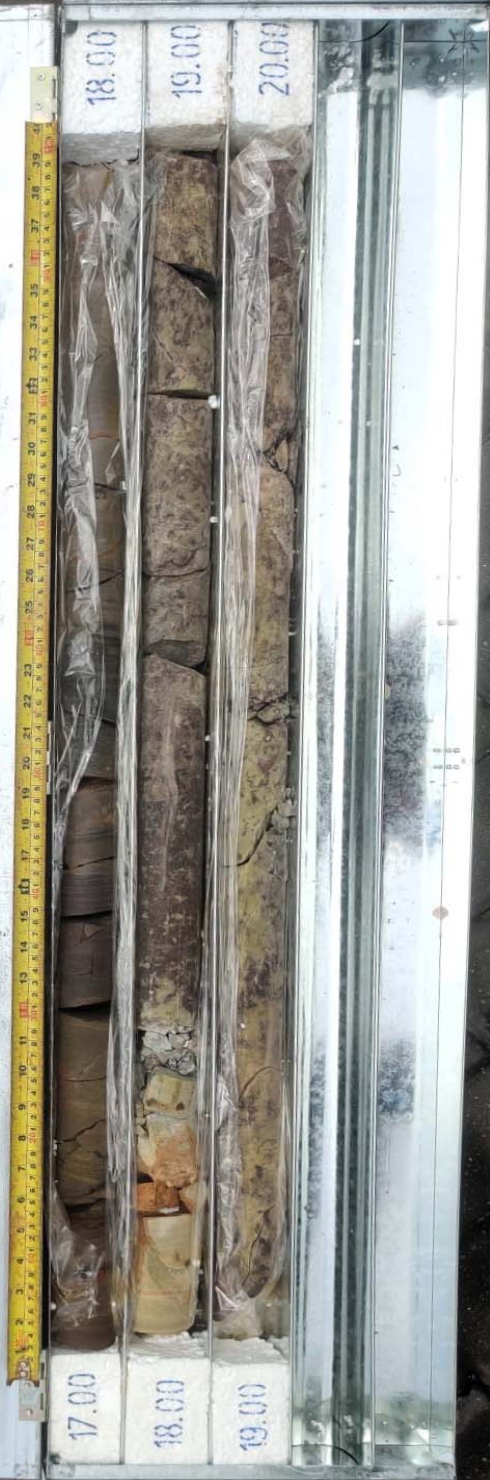
| | | | | BH-09 | | | |

| CLIENT : KEPPEL BAY PTE LTD | | | | CR11 to CR13 | | | |

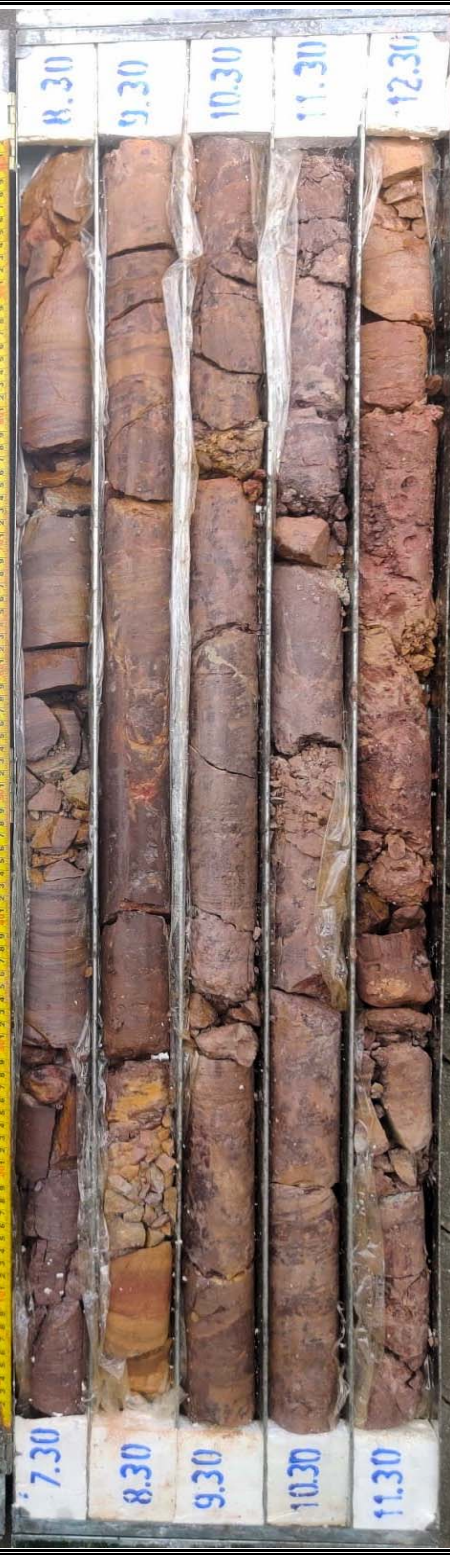
| | | BH-12 | | | | | |

| | | CR6 to CR10 | | | | | |

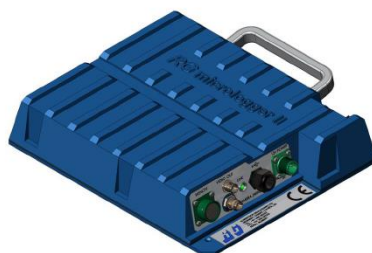
Fig. 2 PS Suspension Micrologger 2.

The Micrologger 2 is a small and highly portable single-unit surface interface system for handling logging data acquisition. Table 2 tabulates the physical specifications of Micrologger 2.

| Figure 2 | PS Suspension Micrologger 2 |
